DEPARTMENT OF TRANSPORTATION**DIVISION OF ENGINEERING SERVICES**

Contract #: 04-0120F4Cty: SF/ALA Rte: 80 PM: 13.2/13.9File #: 1.28**WELDING INSPECTION REPORT****Resident Engineer:** Pursell, Gary**Address:** 333 Burma Road**City:** Oakland, CA 94607**Report No:** WIR-013468**Date Inspected:** 27-Apr-2010**Project Name:** SAS Superstructure**OSM Arrival Time:** 630**Prime Contractor:** American Bridge/Fluor Enterprises, a JV**OSM Departure Time:** 1500**Contractor:** American Bridge/Fluor Enterprises, a JV**Location:** Job Site

3W/4W-A**A3-A5**

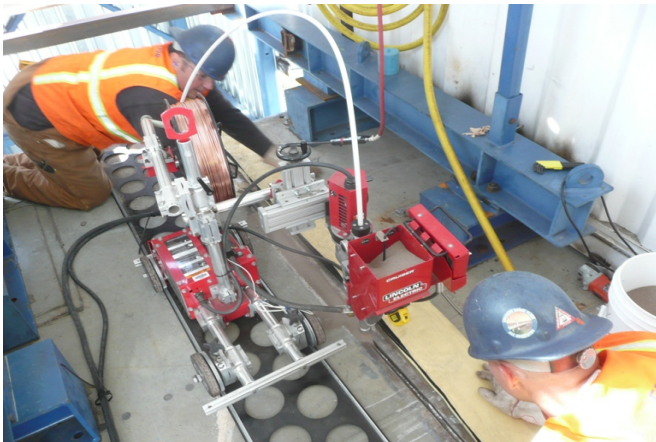
The QA Inspector randomly observed the ABF welders James Zhen and Song Tao Huang setting up to begin performing the SMAW weld joint restoration or "butter" passes at the above identified location. The QA Inspector noted no welding was performed on the QA Inspectors shift only some grinding tasks and preheating in preparation of performing the SMAW vertical weld joint restoration.
